*Annual* **CONFERENCE**

Cairns Convention Centre, Cairns | 12-14 October 2021

# Castle Hill Stairs Case Study: Adopting Innovative Engineering Approaches to Overcome Geotechnical Site Challenges

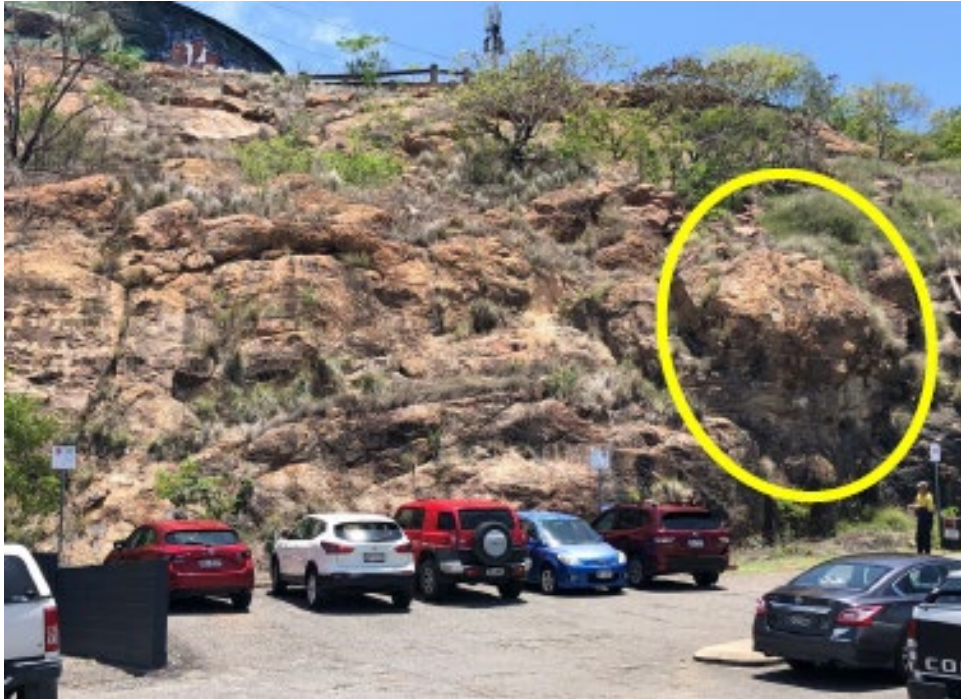
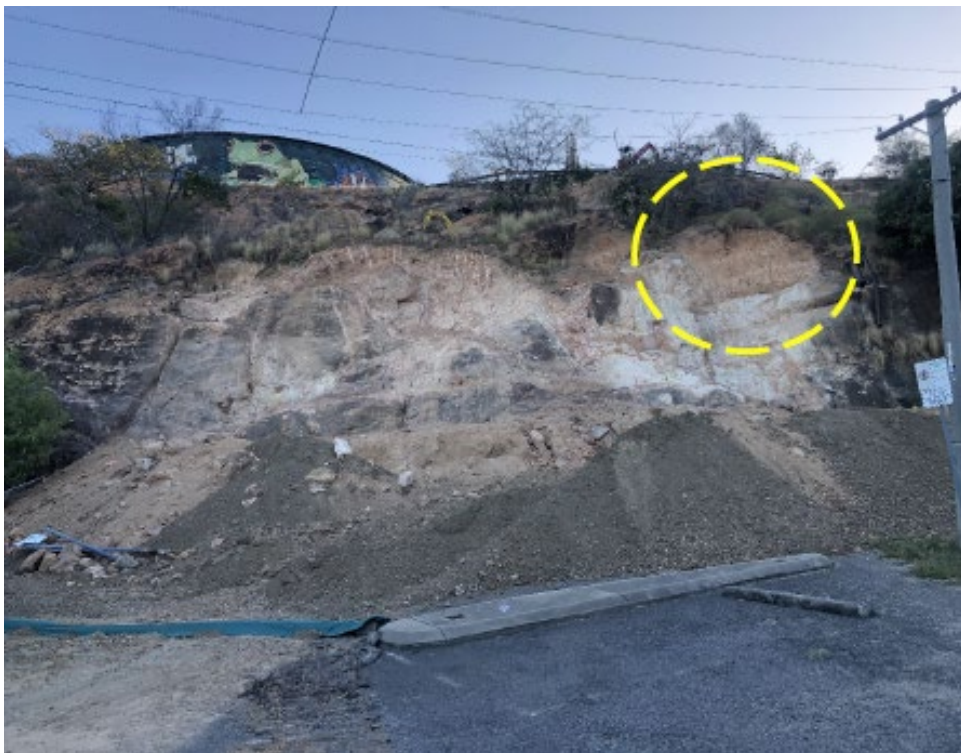
Figure 2 - Hazard remediation

In conjunction with delivering an exciting new Transit to Castle hill, an obligation to reduce the current Hazard status at the location to a safe low or very low criteria was required. The geotechnical hazards already present were assessed and compared to initial geotechnical remediation advice (Parisi, 2020). The process for rectifying the exhibited hazards was a relatively straightforward and practical approach. By utilizing winch assisted spider excavators with rock hammer attachments along with a 35t excavator to scale the cliff face back removing all Hazards on the lower stair site and upper cliff faces thus providing a geometrically satisfactory slope and ideal foundation locations for the staircase footings (Figure 2).

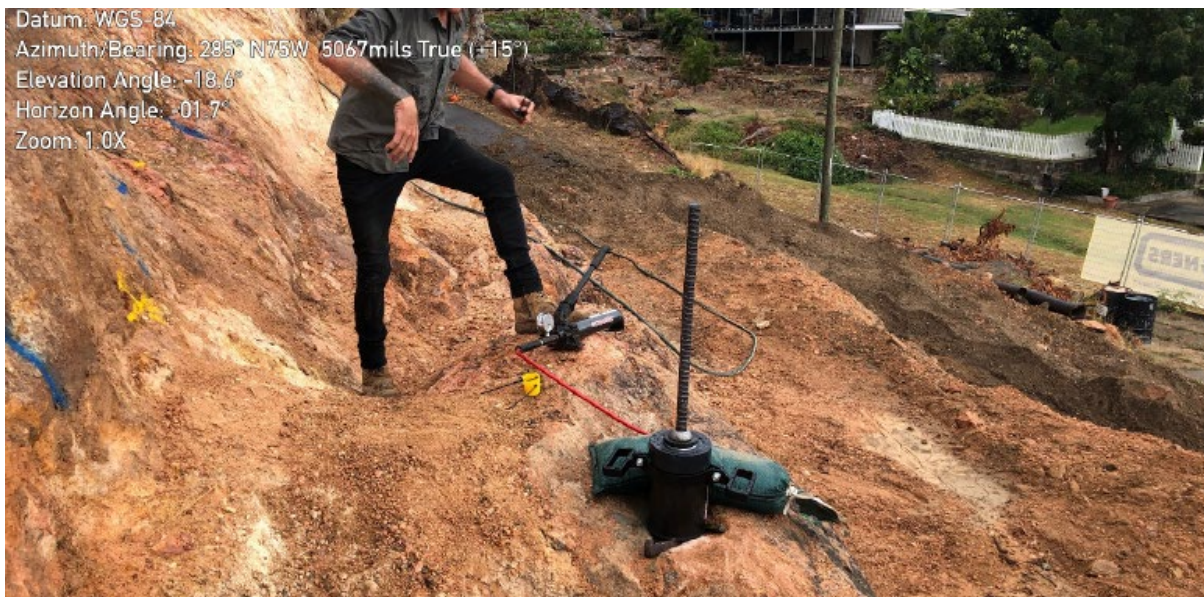
Figure 3 - On-site anchor pull-out test

On-site actual pull-out test was undertaken to assess the actual bond strength of anchored embedded/grouted in the ground as shown in Figure 3. A sacrificial test dowel was used for the test using 28mm diameter, Grade 500N threaded bar grouted in 75mm diameter drilled hole. The hole was 1m deep, with a bond/grouted length of 0.68m. A grout is of 20MPa compressive strength at 2 days was used to fill the drill hole by gravity after the hole was cleaned by compressed air.

The target test load was 160kN, while the maximum safe test load is ~245kN which is based on 80% of the anchor's ultimate tensile strength. The test load was increased incrementally at 20% intervals up to 80% of the safe load. The applied was held for 5min, or until stabilization. The deflection at each step was measured at time intervals of 0, 30s, 60s, 1min, 2min, 3min and 5min. The point of failure is defined as either if total deflection exceeded 0.1% of the dowel bond length, or if creep deflection exceeded 2mm per log time.

The test load reached 1.5 times the target test load without any sign of failure. Then the test was terminated due to reaching the safe load mark.

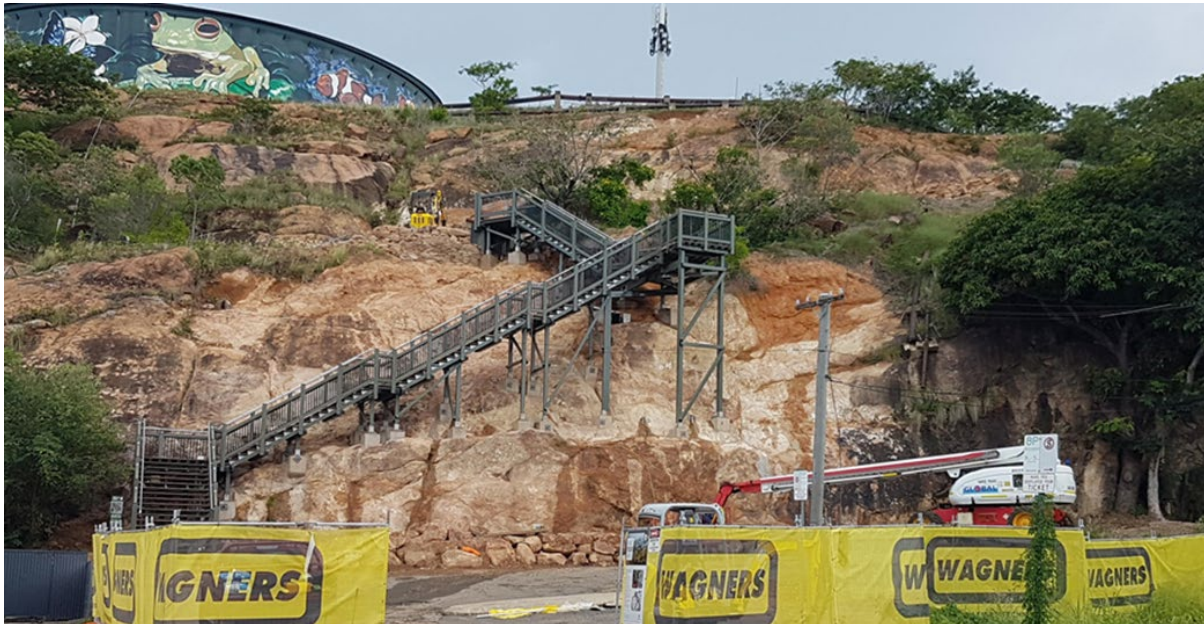
Figure 4 - Installed Castle Hills Stairs

Installation was completed with Local major Subcontractor Enviroedge employed for their specialized equipment and personnel as pictured in Figure 4.
